Manhole Inspection Summary

Manhole # S13KK_016MH

Insp Date: **2/24/09 1:25 PM**

Location Address: **ASHBURTON AVE**

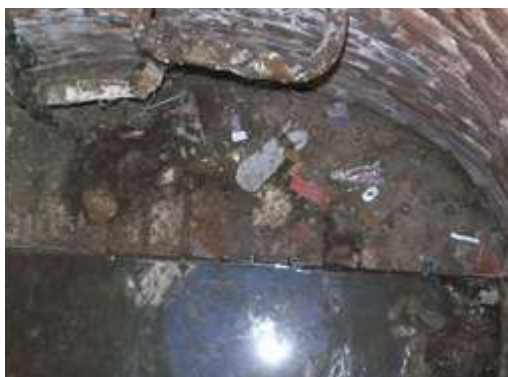
Defect 1

Surcharge ☒ **Evidence Of Surcharge** Depth: **3** (ft.) ☐ Active Surcharge Present

ASUR

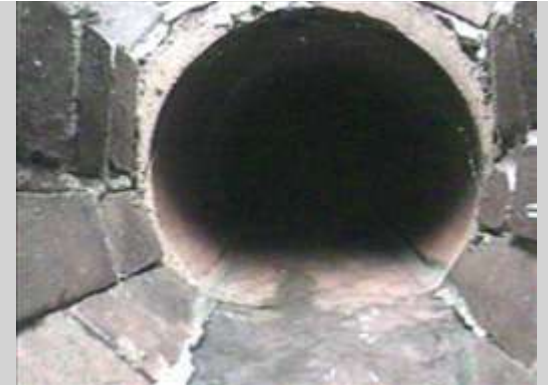
12 O'Clock Outflow

10 in. Circular Gravity Sewer
Pipe Out @ 12 O'Clock

Pipe Height: (in.) Direct
Pipe Material: **Clay** ☐ Pipe Lined
Invert Depth: **7.81** (ft.) Flow Characteristics: **Slow**
Deposits: ☒ None ☐ Mud ☐ Sludge ☐ Debris ☐ Grease
Silt Depth: (in.) Deposits Extent:
Infiltration: **None** Pipe Seal Cond: **Cracked**

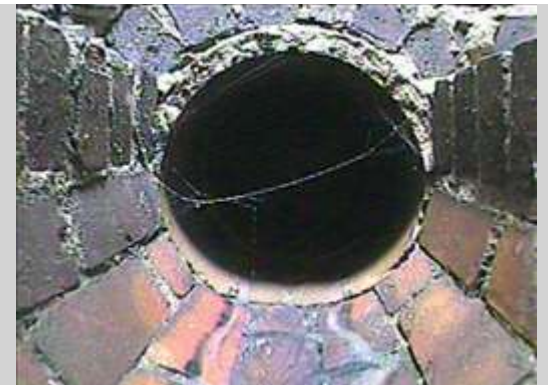
6 O'Clock Inflow

10 in. Circular Gravity Sewer
Pipe In @ 6 O'Clock

Pipe Height: (in.) Direct
Pipe Material: **Clay** ☐ Pipe Lined
Invert Depth: **7.69** (ft.) Flow Characteristics: **Slow**
Deposits: ☒ None ☐ Mud ☐ Sludge ☐ Debris ☐ Grease
Silt Depth: (in.) Deposits Extent:
Infiltration: **None** Pipe Seal Cond: **Broken**
